## Midwest Guardrail System for Standard and Special Applications

**Transportation Research Board**  
83<sup>rd</sup> Annual Meeting  
January 11-15, 2004  
Washington, D.C.

**ABSTRACT**

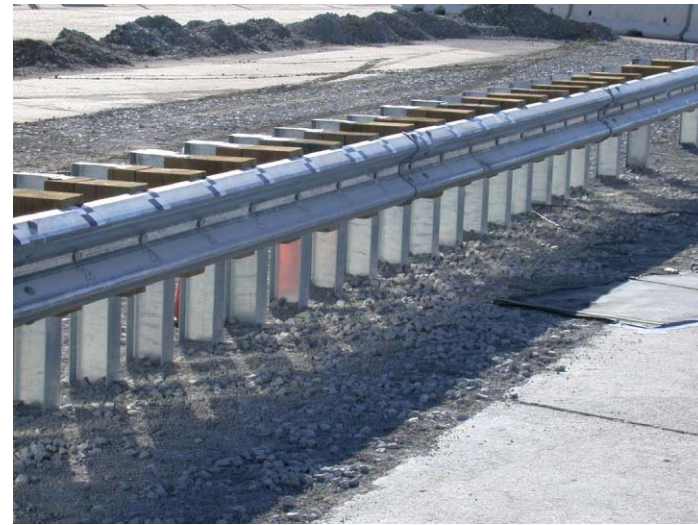
**FIGURE 3 Midwest Guardrail System for Special Applications: (a) Quarter-Post Spacing (Design B), (b) Standard Post Spacing With AASHTO Type B Curb (Design C) [1 in. = 25.4 mm].**

The second test installation (Design B) was identical to the first system (Design A) except that the original guardrail system was stiffened through the use of a reduced post spacing. Post nos. 9 through 11 and 51 through 53 were spaced 952.5 mm (37 ½ in.) on center while post nos. 11 through 51 were spaced 476.25 mm (18 ¾ in.) on center. The standard 2.66-mm (12-gauge) thick W-beam rails located between post nos. 9 and 53 were modified to include additional post bolt slots at half- and quarter-post spacing intervals, as shown in Figure 3(a).

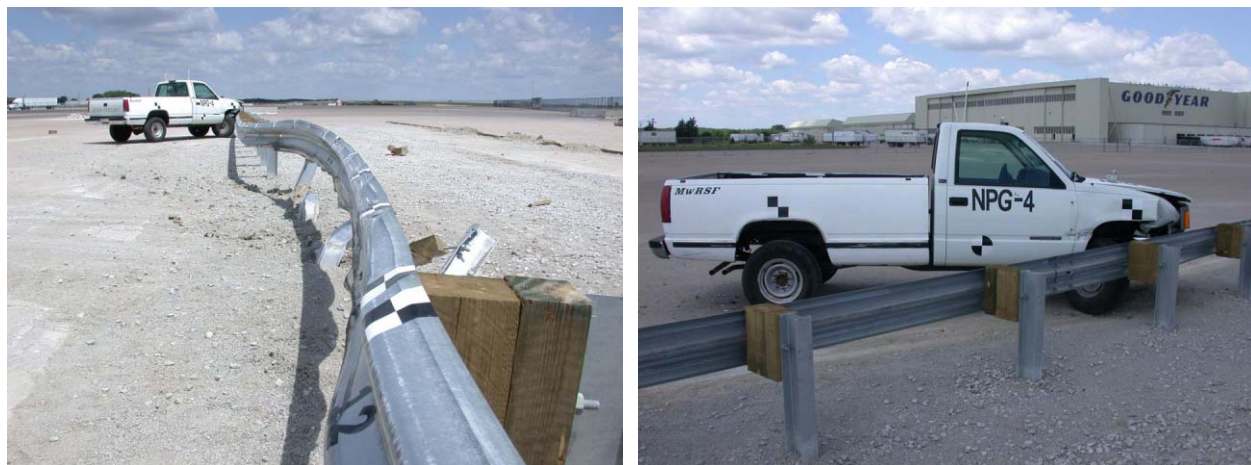
**FIGURE 5 Barrier and Vehicle Damage – (a) Test No. NPG-4, (b) Test No. NPG-6, (c) Test No. NPG-5.**

For test no. NPG-4, a 1,986-kg (4,378-lb) pickup truck impacted the *Midwest Guardrail System* with standard post spacing (Design A) at a speed of 98.1 km/hr (61.0 mph) and at an angle of 25.6 degrees. Initial impact occurred 4,839 mm (190 ½ in.) upstream from the centerline of the splice between post nos. 14 and 15, as shown in Figure 4. At 0.396 sec after impact, the vehicle became parallel to the guardrail with a resultant velocity of 61.2 km/hr (38.0 mph). The vehicle was safely redirected in a very stable manner with very little roll or pitch. At 0.597 sec, the vehicle exited the guardrail at a trajectory angle of 19.3 degrees and at a resultant velocity of 55.1 km/hr (34.2 mph). Exterior vehicle damage was minimal, consisting of minor right-front corner deformations, and there was no observable occupant compartment deformations. Damage to the barrier was moderate, consisting mostly of deformed W-beam and guardrail posts, contact marks on a guardrail section, and disengaged wooden blockouts. Maximum dynamic barrier deflection was 1,094 mm (43 in.) at the midspan between post nos. 14 and 15, and the system’s working width was 1,260 mm (50 in.). The vehicle and barrier damage are shown in Figure 5(a). A summary of the test results and the sequential photographs are shown in Figure 4. Test no. NPG-4 conducted on Design A was determined to be acceptable according to the NCHRP Report No. 350 safety performance criteria.
